Hossein Derakhshan, Dmytro Dizhur, Michael C. Griffith, and Jason M. Ingham
In situ out-of-plane testing of as-built and retrofitted unreinforced masonry walls
Journal of Structural Engineering, 2014; 140(6):04014022-1-04014022-12

1 Title: In-situ out-of-plane testing of as-built and retrofitted unreinforced masonry walls
2 Hossein Derakhshan¹, Dmytro Dizhur², Michael C. Griffith³, and Jason M. Ingham⁴, M.ASCE

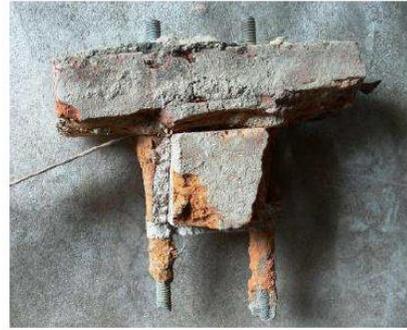
Fig. 1: Grouted steel anchors (SA)

(a) Steel anchors in demolished wall

(b) Anchorage details

(c) Anchorage sketch

54 Included within this research program were walls having grouted vertical steel anchor bars (SA;
55 Fig. 1) regularly spaced along the top edge, and a wall having a concrete ring beam (CB) placed
56 along the top edge. The provision of steel anchor bars at the wall top edge has often been
57 included as part of URM building retrofit projects, with the purpose being to promote wall
58 deformations in a simply-supported mode as opposed to a cantilever mode. The presence of a
59 concrete ring beam at building floor levels promotes arching actions that improve the wall out-
60 of-plane behavior. As opposed to confined masonry wall construction, the wall tested with a CB
61 support type in this research program had no vertical concrete ties.

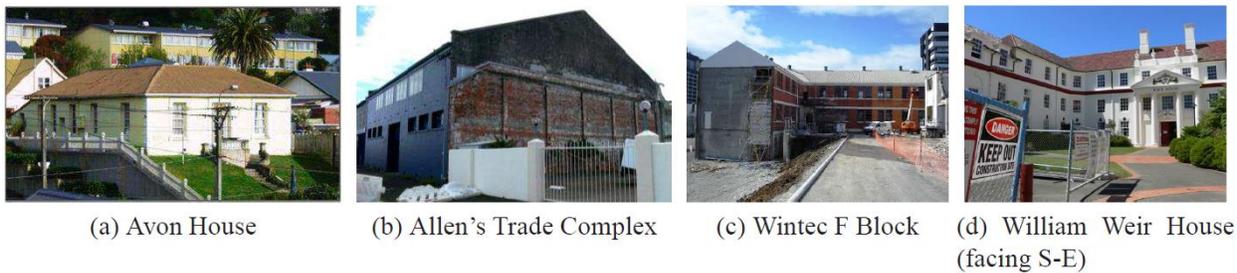
Fig. 3: Case study buildings

140 (AH; Fig. 3a; built 1884), Allen's Trade Complex (AT; Fig. 3b; built 1911), and Wintec F Block

141 (WT; Fig. 3c; built 1917). These three buildings were constructed using clay bricks and timber

149 Tests were also conducted on single-wythe unreinforced terracotta hollow block masonry
150 partition walls of the three-storey William Weir House (WH; Fig. 3d; built 1932), which had a
151 reinforced concrete frame with concrete floor slabs and a timber roof. These tests were
152 conducted with the walls loaded in a two-way bending condition and included two apparently
153 undamaged walls and two pre-cracked partition walls. The building is located in a highly seismic
154 region of New Zealand (Wellington), and had been subject to prior earthquakes. The 24 June
155 1942 Wairarapa earthquake (M7.2, Modified Mercalli in Wellington: 6 to 7 depending on ground
156 structure) and the 02 August 1942 Wairarapa earthquake (M7, Modified Mercalli in
157 Wellington: 6) occurred 10 years after the building had been constructed, with widespread
158 collapse of chimneys, masonry walls and parapets into Wellington streets being reported

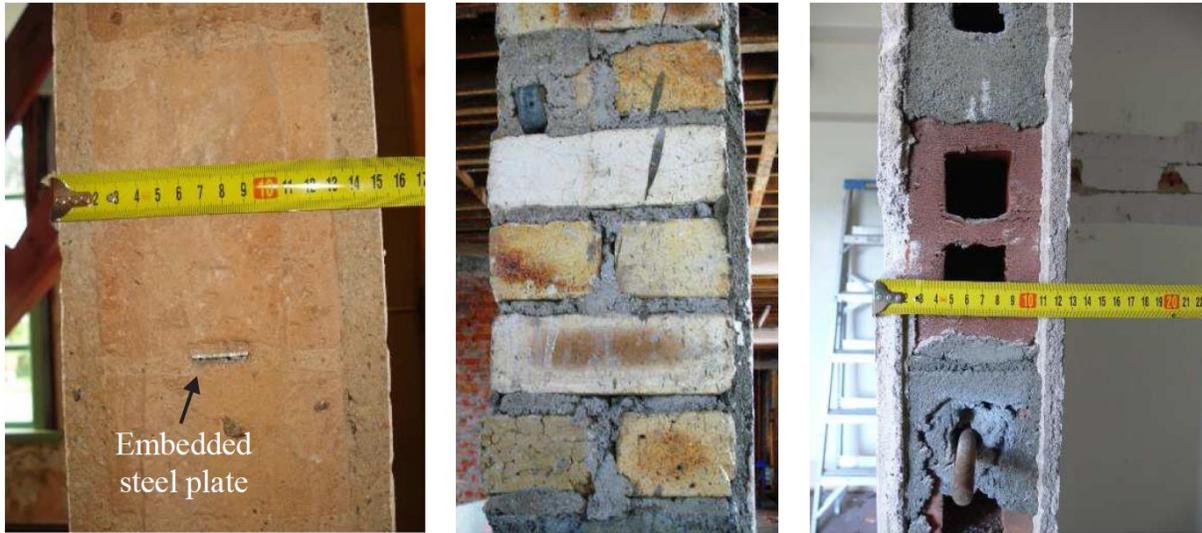
Fig. 4: Typical wall cross section

(a) AH (b) AT and WT (c) WH

190 AH1 and AH2 were two similar test strips of a single partition wall, with steel plates embedded
191 in three of the mortar joints of the wall (see Fig. 4a). The severely corroded plates were
192 considered to not increase wall strength for the one-way bending condition.

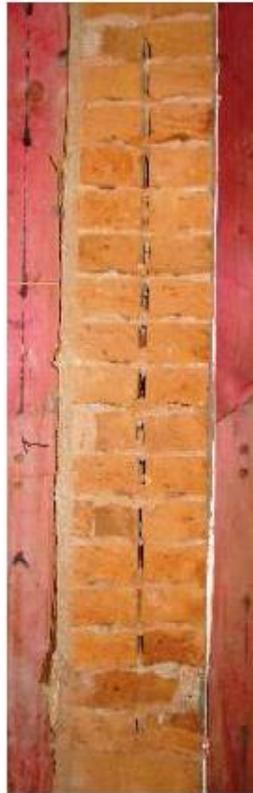
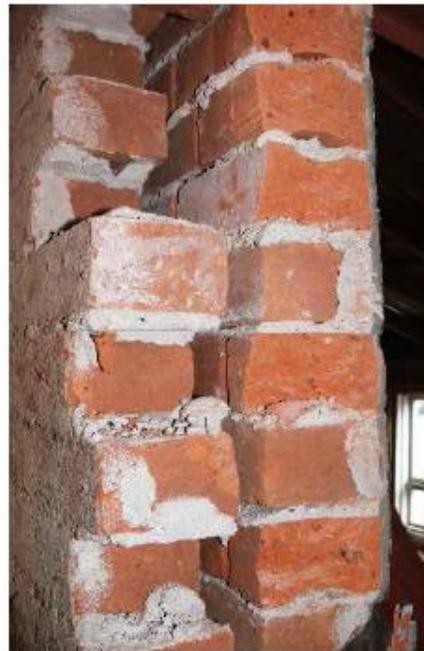
Fig. 7: Scarcity of header bricks in a two-leaf wall

(a) Wall cross section

(b) Wall disintegration

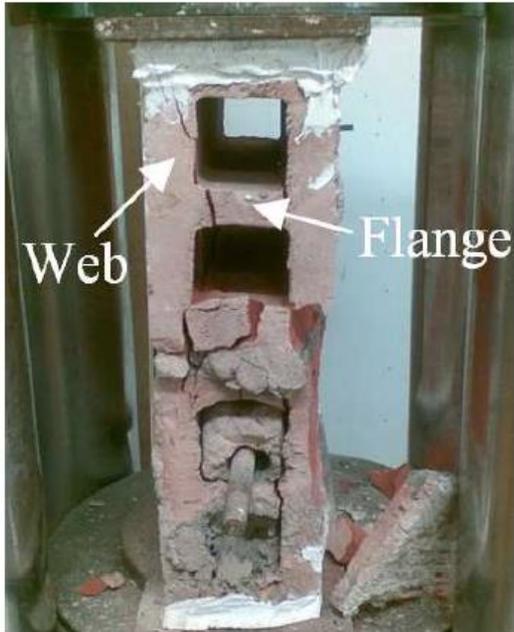
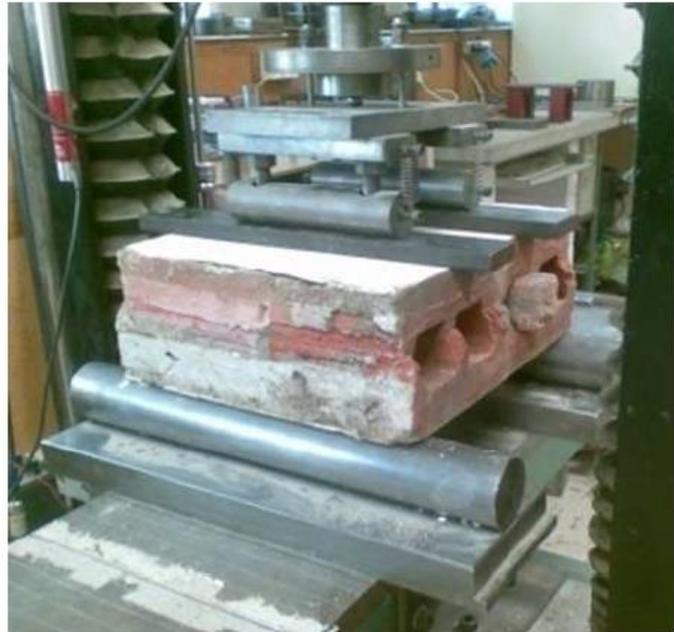
Fig. 8: Material testing on building WH

(a) Masonry prism testing

(b) Four-point bending test

221
222 The masonry flexural bond strength (f'_{fb}) for building WH was derived from four point bending
223 tests performed in the laboratory on masonry beam samples that included the plaster layer
224 (Fig. 8b), but the strength value reported for building AH was determined on site following
225 ASTM 1072 – 00a (ASTM 2001) after removing the plaster layer. As 50 mm mortar cube
226 samples required for mortar testing using the procedure recommended in ASTM C780-02
227 (ASTM 2002) are unattainable from actual buildings, irregular mortar samples were cut into
228 measurable cubic shapes and tested in compression. The average length, width and height of

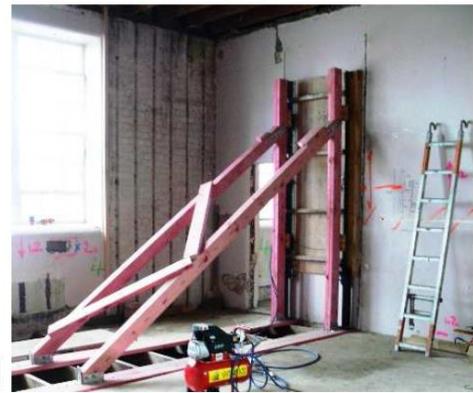
Figure 9: Typical in-field test setup details

(a) Test setup diagram for WT-A; inset: top support details for other walls

(b) Actual setup (WT-A)

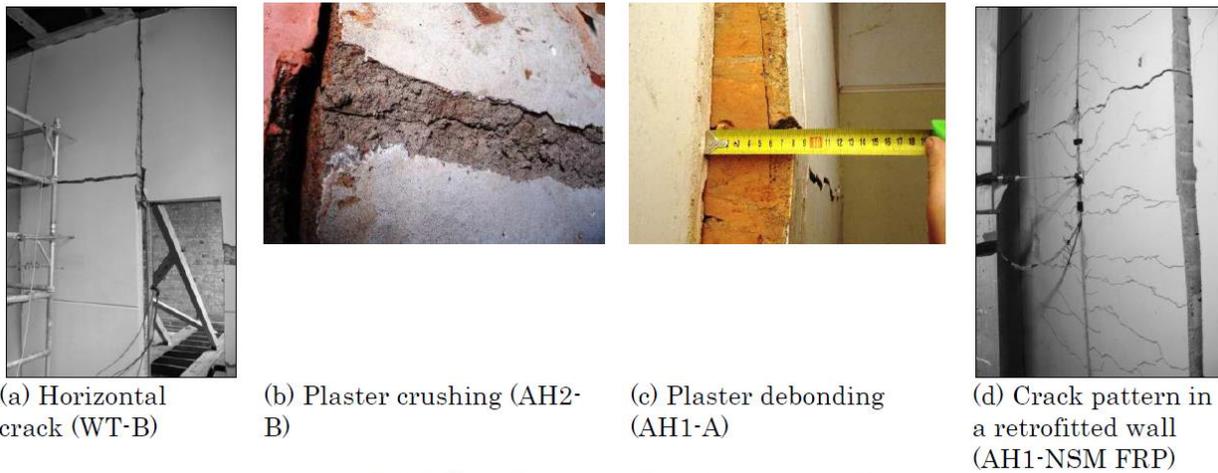
Fig. 11: Wall cracking and deterioration of plaster

290 In the one-way spanning as-built walls, a crack occurred at the wall base, and the walls
291 developed an approximately horizontal crack (Fig. 11a) at an intermediate height of βh above the
292 wall base, with β being on average 0.56. The intermediate height crack was horizontal in all
293 tests except test AH3-A, in which the crack crossed three brick courses. The cracking pattern in

308 Subsequent testing on retrofitted walls resulted in numerous new cracks being formed in the
309 vicinity of the inserted strip or steel bar, with the final crack pattern for one test being shown in
310 Figs. 11d.

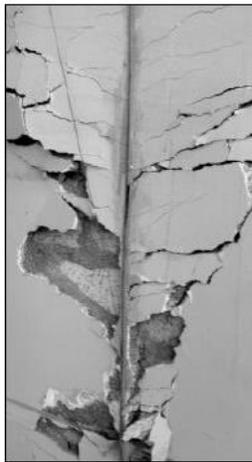
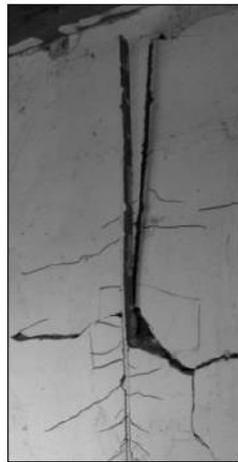
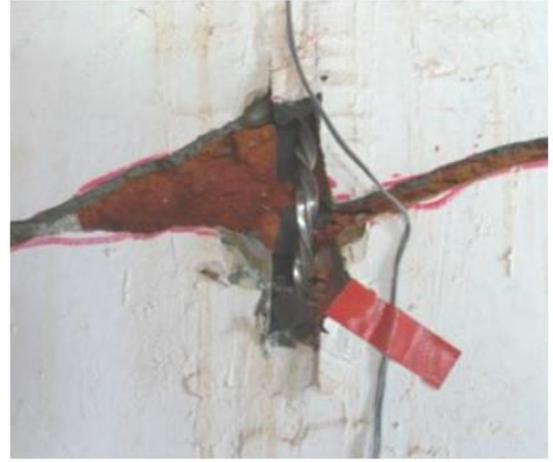
Fig. 13: Failure modes in retrofitted walls

(a) Strip debonding
(WT – NSM FRP)

(b) Strip pull-out
(AH3 – NSM FRP)

(c) Local bending of a TSB (AH2 –
NSM TSB)

360 strip (see Fig. 13a for same failure mode for test WT-NSM FRP). Strip rupture, a brittle failure
361 mode associated with the NSM FRP strengthening technique, was not observed as the peak
362 measured stresses that developed in the strip were only 40% of that necessary to cause strip
363 rupture. The maximum strain measured in the CFRP strip during test AH1-NSM FRP was 7500
364 $\mu\epsilon$ (analogous to a tensile stress of 1240 MPa) compared to the CFRP manufacturer's suggested
365 maximum design tensile strength of 3100 MPa. The failure mode in AH2-NSM TSB was in the
366 form of local cracking of masonry and local bending of the TSB (Fig. 13c).
